# WHITE PAPER

# **CONTAMINANT SOURCES**

# PREMIER EDIBLE OIL SITE (ESCI # 2013)

# PORTLAND HARBOR SUPERFUND SITE

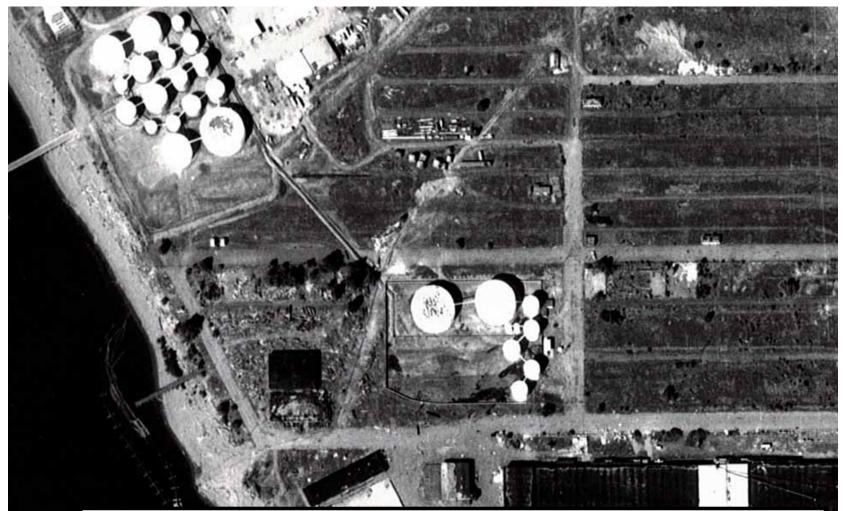
## Photo 12

# August 29, 1968 - Aerial photograph of the PEO Site and Northwest Terminal

Note the dark staining in the v-shaped depression west of Tank 12003, as well as staining on the south side of Tank 12003. The Bell Oil Terminal dock appears operable.

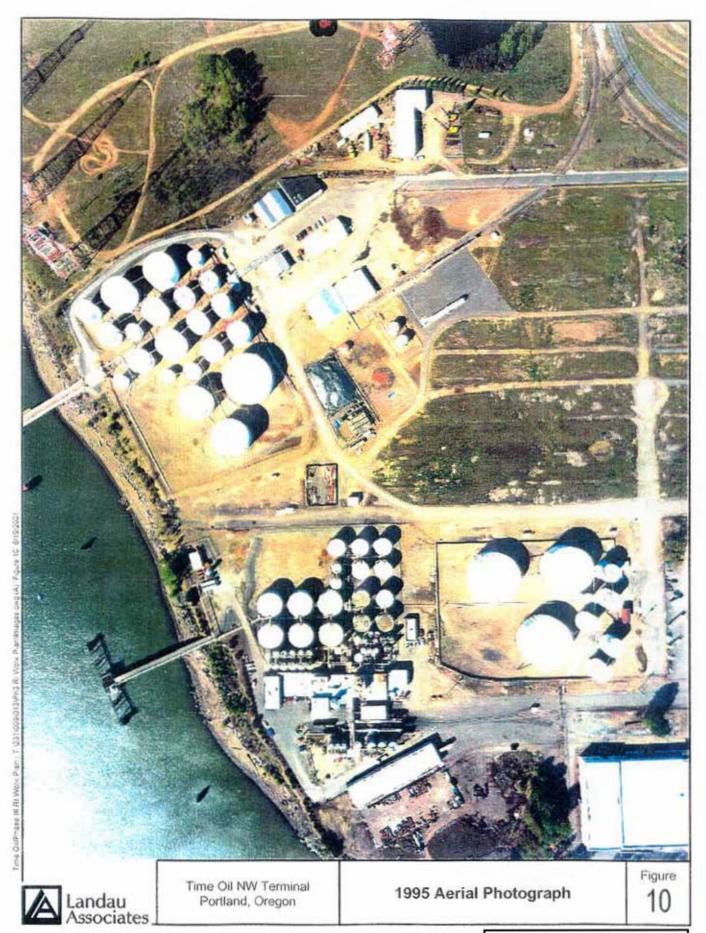
Photo 24 1995 - Aerial photograph of the PEO Site, the Bell Oil Terminal, and the Northwest Terminal

In reviewing the aerial photos previously submitted by Landau in its *Phase III Work Plan*, we find but one photo that potentially addresses Time Oil's allegation. It is a 1995 aerial, reproduced herein as Photo 24.<sup>31</sup> Photo 24 depicts certain personal vehicles parked around the small office building located immediately west of the PEO Site/Bell Oil Terminal property line. However, there is no evidence of oil leakage or apparent soil staining in that photo. Any minor oil drips or leakage from a parked vehicle would be more than dwarfed by even the smallest of the *incidental spills* that Time Oil acknowledges probably occurred during the half-century of operation of its multi-million gallon fuel storage facility on the adjacent and upgradient Bell Oil Terminal property.
